**Flood Control Project Maintenance
Levee Inspections**
LMA District Cover Sheet
Spring 2019 Levee Inspection Results

Reclamation District No. 0001 Union Island

Levee Inspection Report By Mile - Spring 2019

Waterway	Bank	Unit Miles	Inspection Start/End	Inspector
Unit No. 01 Old River	Right	1.14	04/04/2019 04/04/2019	Alberto De Leon

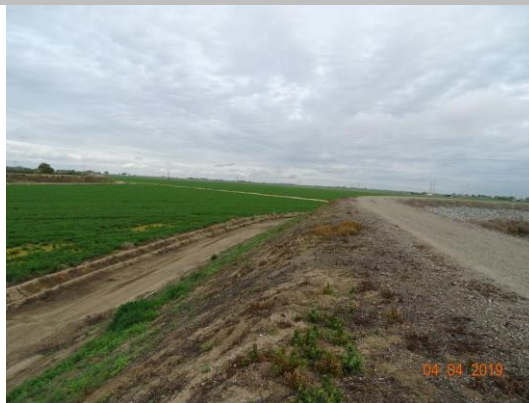
Photo 1 of 1 : SP_2019_RD0001_23_13_20190415_00025.jpg

LM Start	0.00	Rating **	A	Issue No.	13
LM End	1.14	Issue Type +	Ma	Location *	LS
Category	Earthen Levee			GPS Latitude/Longitude	
				Start	End
Item	Vegetation			37.822580 °	37.811714 °
				-121.375545 °	-121.384876 °
DWR ID	DWR_RD0001_01_f_2018_13				
Comment Code					
V1 : Control annual grass and weeds on the levee slopes and easements.					
Inspector Comment					
The annual vegetation is well maintained.

View looking upstream landside at the well maintained annual vegetation, Spring 2019.

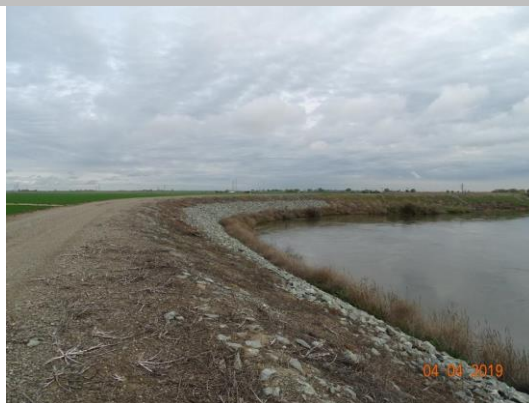
Photo 1 of 1 : SP_2019_RD0001_23_20_20190415_00026.jpg

LM Start	0.00	Rating **	A	Issue No.	20	
LM End	1.14	Issue Type +	Ma	Location *	WS	
Category	Earthen Levee			GPS Latitude/Longitude		
				Start		End
Item	Vegetation			37.822585 °		37.811714 °
				-121.375532 °		-121.384876 °
DWR ID	DWR_RD0001_01_f_2018_20					
Comment Code						
V1 : Control annual grass and weeds on the levee slopes and easements.						
Inspector Comment						
The annual vegetation is well maintained.

View looking upstream waterside at the well maintained annual vegetation, Spring 2019.

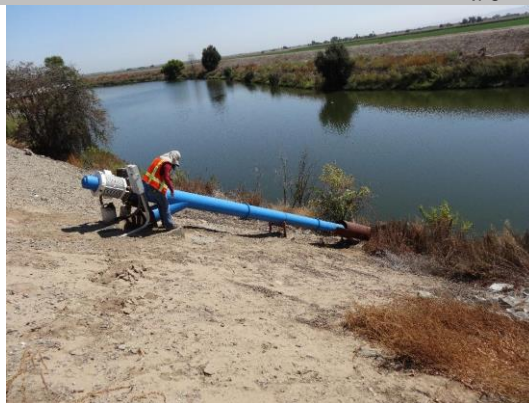
Photo 1 of 3 : UCIP_SP_2019_52628_36036.jpg

LM Start	0.02	Rating **	M	Issue No.	24
LM End	0.02	Issue Type +	En	Location *	
Category	Supplemental			GPS Latitude/Longitude	
				Start	End
Item	DWR UCIP Field Study			37.822433 °	37.822433 °
				-121.375734 °	-121.375734 °
DWR ID	22688

Comment Code					
Inspector Comment					
FS_ID:52628 DS_ID:22688 EP_NO: 6708 Repair Type: Non-Urgent Crossing Status: Found UCIP Comments: - Pipe has leaks on WS that may cause erosion to slope.- 2" electric conduit on WS.- power pole on LS FIELD_STRUCT_DESC: 12-inch coated steel irrigation discharge pipe through the levee, 5 feet below the crown. Slant pump on the waterside (WS) slope. Air valve on the landside (LS) shoulder. Electrical conduit through the levee. Pipe discharges into a distribution box on the LS toe. (Plans to install a new pump and pipe through the levee authorized under Permit No. 6708, 1969 - Cyril S. Lamb Jr.). [Additional Reference(s): DWR Levee Log, 2005]. FS Date: 5/30/2018

WS view: steel pipe and slant pump on levee slope. Pump on concrete pad.

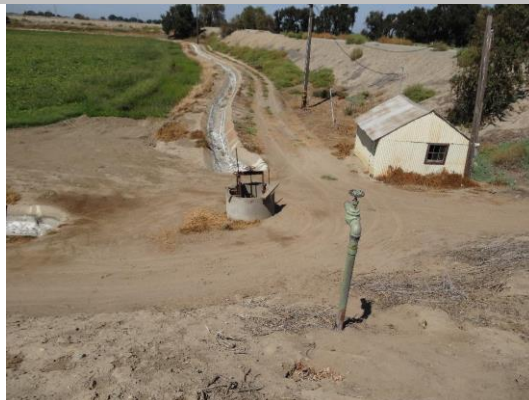
Photo 2 of 3 : UCIP_SP_2019_52628_36034.jpg

LS view: air relief valve on levee slope and concrete distribution box on levee toe.

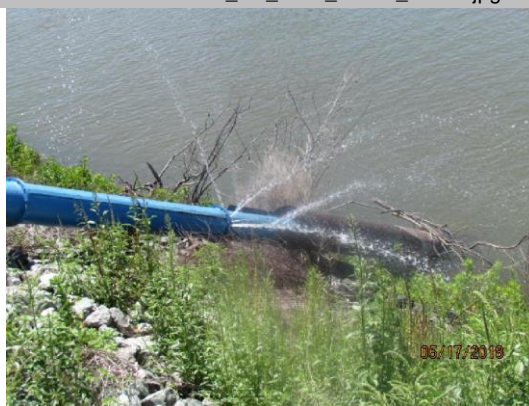
Photo 3 of 3 : UCIP_SP_2019_52628_77561.jpg

Comment Code						
Inspector Comment						
FS_ID:52628 DS_ID:22688 EP_NO: 6708 Repair Type: Non-Urgent Crossing Status: Found UCIP Comments: - Pipe has leaks on WS that may cause erosion to slope.- 2" electric conduit on WS.- power pole on LS FIELD_STRUCT_DESC: 12-inch coated steel irrigation discharge pipe through the levee, 5 feet below the crown. Slant pump on the waterside (WS) slope. Air valve on the landside (LS) shoulder. Electrical conduit through the levee. Pipe discharges into a distribution box on the LS toe. (Plans to install a new pump and pipe through the levee authorized under Permit No. 6708, 1969 - Cyril S. Lamb Jr.). [Additional Reference(s): DWR Levee Log, 2005]. FS Date: 5/30/2018

WS view: leaking irrigation pipe may cause damage to WS slope.

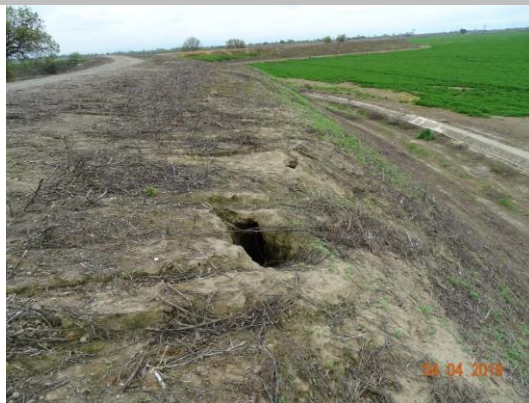
Photo 1 of 1 : SP_2019_RD0001_23_23_20190415_00027.jpg

LM Start	0.15	Rating **	U	Issue No.	23
LM End	0.15	Issue Type +	Ma	Location *	LS
Category	Earthen Levee			GPS Latitude/Longitude	
				Start	End
Item	Animal Control			37.821610 °	37.821610 °
				-121.377962 °	-121.377962 °
DWR ID	DWR_RD0001_01_s_2019_23				
Comment Code					
A3 : No rodents visible, but rodent burrows visible; need to backfill and compact or grout burrows.					
Inspector Comment					
A large rodent hole is located on the landside shoulder. It is approximately 3 ft. x 2 ft. and needs to be repaired. (Spring 2019)

View looking landside at large rodent hole on levee slope, Spring 2019.

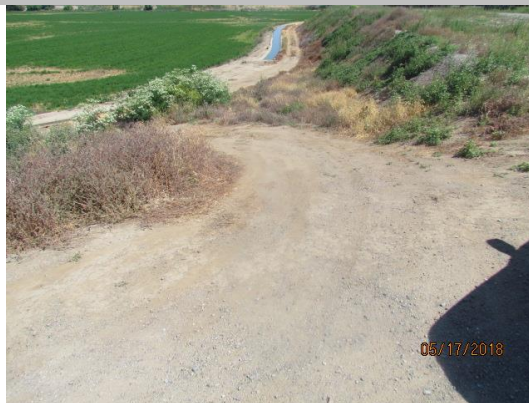
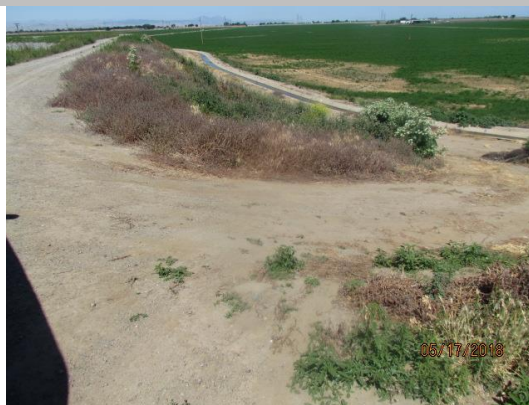
LM Start	0.25	Rating **	U	Issue No.	17
LM End	0.25	Issue Type +	En	Location *	LS
Category	Earthen Levee			GPS Latitude/Longitude	
				Start	End
Item	Encroachments			37.820298 °	37.820298 °
				-121.378457 °	-121.378457 °
DWR ID	DWR_RD0001_01_s_2018_17				
Comment Code					
RA : Ramp					
Inspector Comment					
Unauthorized ramp on landward slope.

Looking east at unauthorized ramp on landward slope. (Spring 2018)

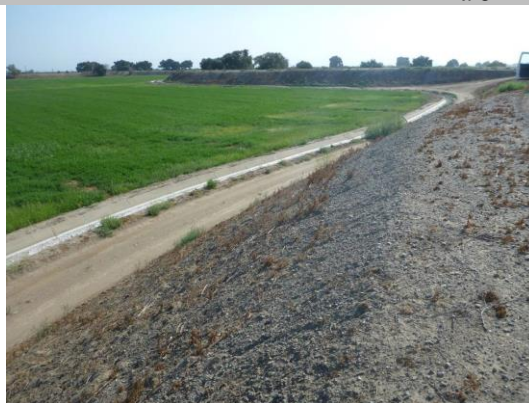
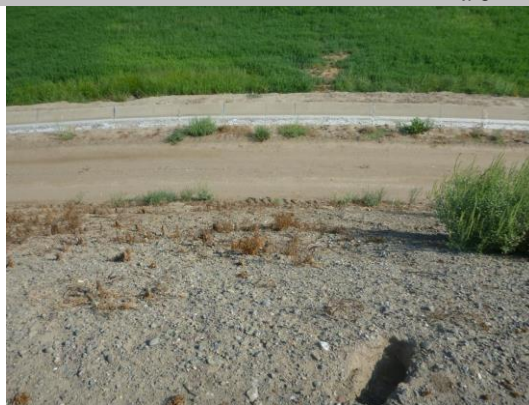
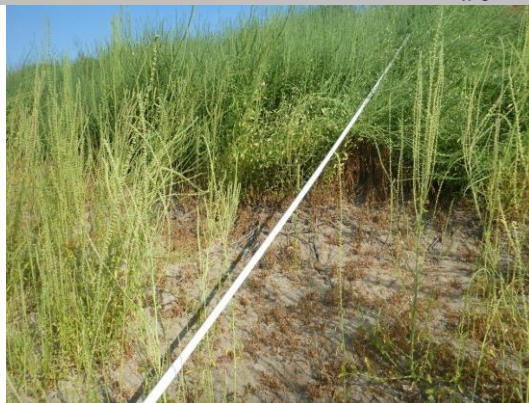
LM Start	0.31	Rating **	M	Issue No.	11
LM End	0.33	Issue Type +	Ma	Location *	
Category	Supplemental			GPS Latitude/Longitude	
				Start	End
Item	2017 Storm Damage			37.820300 °	37.820200 °
				-121.379500 °	-121.379800 °
DWR ID	DWR_RD0001_01_f_2017_11				
Comment Code					
Inspector Comment					
Levee Evaluation Comments					
Description:Slope protection repairs are needed along the waterside slope due to erosion and riprap displacement from high water. Based upon levee inspections, it was determined the waterside levee slope is eroding, deteriorating, and degrading. The eroded levee sections need to be restored back to design standards to prevent further deterioration and damage.					
Site ID No:496					
Site Designation:LMA-402					
Repair Type: Erosion					
Rating:Area of Concern					
Field Date:8/18/2017					
Notes: Start of outside bend. Minor toe erosion has displaced riprap.

Comment Code						
Inspector Comment						
Levee Evaluation Comments						
Description:Slope protection repairs are needed along the waterside slope due to erosion and riprap displacement from high water. Based upon levee inspections, it was determined the waterside levee slope is eroding, deteriorating, and degrading. The eroded levee sections need to be restored back to design standards to prevent further deterioration and damage.						
Site ID No:496						
Site Designation:LMA-402						
Repair Type: Erosion						
Rating:Area of Concern						
Field Date:8/18/2017						
Notes: Start of outside bend. Minor toe erosion has displaced riprap.

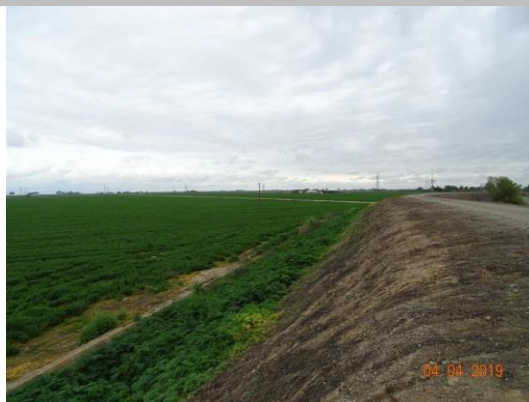
Photo 1 of 1 : SP_2019_RD0001_23_22_20190415_00029.jpg

LM Start	0.42	Rating **	M	Issue No.	22
LM End	0.48	Issue Type +	Ma	Location *	LS
Category	Earthen Levee			GPS Latitude/Longitude	
				Start	End
Item	Vegetation			37.819162 °	37.818412 °
				-121.380438 °	-121.379993 °
DWR ID	DWR_RD0001_01_s_2019_22				
Comment Code					
V2 : Remove the wild growth other than native grasses from the levee slopes.					
Inspector Comment					
There is heavy vegetation between the landside toe and the concerte ditch which needs to be removed. Spring 2019

View of landside levee toe with heavy vegetation parallel to concrete lined ditch, spring 2019.

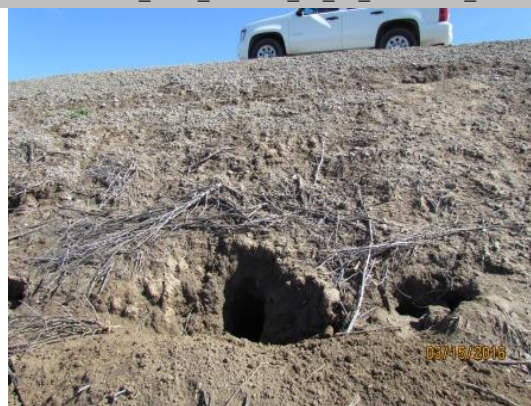
Photo 1 of 1 : SP_2019_RD0001_23_14_20190313_00012.jpg

LM Start	0.44	Rating **	U	Issue No.	14
LM End	0.44	Issue Type +	Ma	Location *	LS
Category	Earthen Levee			GPS Latitude/Longitude	
				Start	End
Item	Animal Control			37.818898 °	37.818898 °
				-121.380332 °	-121.380332 °
DWR ID	DWR_RD0001_01_s_2016_14				
Comment Code					
A1 : Exterminate rodents and backfill and compact or grout burrows.					
Inspector Comment					
There is an active rodent den the size of a coyote or fox.

View of the large rodent hole on the landside levee slope.

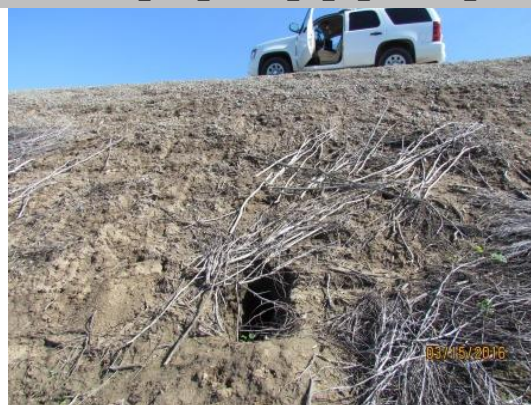
Photo 1 of 1 : SP_2019_RD0001_23_10_20190313_00006.jpg

LM Start	0.45	Rating **	U	Issue No.	10
LM End	0.45	Issue Type +	Ma	Location *	LS
Category	Earthen Levee			GPS Latitude/Longitude	
				Start	End
Item	Animal Control			37.818753 °	37.818753 °
				-121.380249 °	-121.380249 °
DWR ID	DWR_RD0001_01_s_2016_10				
Comment Code					
A3 : No rodents visible, but rodent burrows visible; need to backfill and compact or grout burrows.					
Inspector Comment					
Backfill the rodent hole and compact levee slope with acceptable levee fill.

View of the large rodent hole on the landside levee slope.

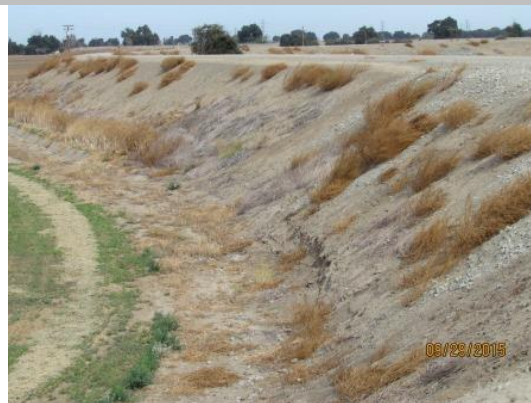
Photo 1 of 1 : SP_2019_RD0001_23_5_20190313_00004.jpg

LM Start	0.51	Rating **	M	Issue No.	5
LM End	0.51	Issue Type +	Ma	Location *	LS
Category	Earthen Levee			GPS Latitude/Longitude	
				Start	End
Item	Slope Stability			37.818003 °	37.818003 °
				-121.379845 °	-121.379845 °
DWR ID	DWR_RD0001_01_f_2015_5				
Comment Code					
S1 : Repair slope instability.					
Inspector Comment					
About a 1 ft. vertical cut is observed at the landside levee toe. Repair the landside levee toe per O&M standards.

View of the vertical cut at the landside levee toe.

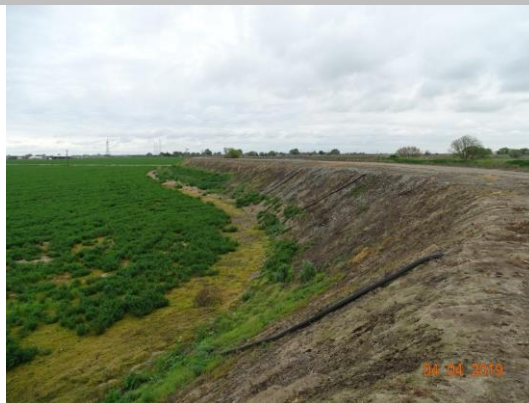
Photo 1 of 1 : SP_2019_RD0001_23_21_20190415_00028.jpg

LM Start	0.52	Rating **	A/W	Issue No.	21
LM End	0.52	Issue Type +	En	Location *	LS
Category	Earthen Levee			GPS Latitude/Longitude	
				Start	End
Item	Encroachments			37.817863 °	37.817863 °
				-121.379813 °	-121.379813 °
DWR ID	DWR_RD0001_01_s_2019_21				
Comment Code					
PI : Pipe					
Inspector Comment					
There are landside drain pipes from the shoulder to landside toe. These were installed to prevent erosion rills. The drainage pipes are not permitted. There are three near this location. Spring 2019

View of landside levee showing surface drainage pipes installed to prevent erosion, Spring 2019.

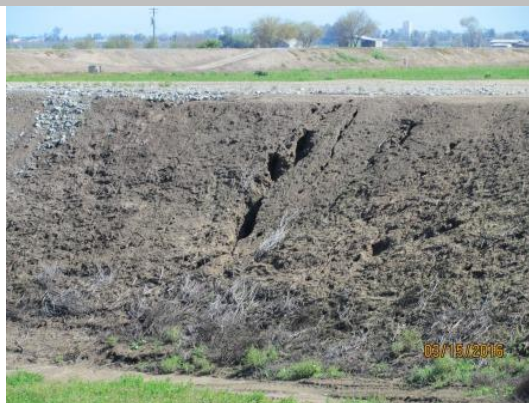
Photo 1 of 1 : SP_2019_RD0001_23_7_20190313_00005.jpg

LM Start	0.52	Rating **	M	Issue No.	7
LM End	0.52	Issue Type +	Ma	Location *	LS
Category	Earthen Levee			GPS Latitude/Longitude	
				Start	End
Item	Erosion / Bank Caving			37.817825 °	37.817825 °
				-121.379811 °	-121.379811 °
DWR ID	DWR_RD0001_01_s_2016_7				
Comment Code					
E2 : Schedule repair of erosion site prior to the next inspection.					
Inspector Comment

View of the erosion on the landside levee slope.

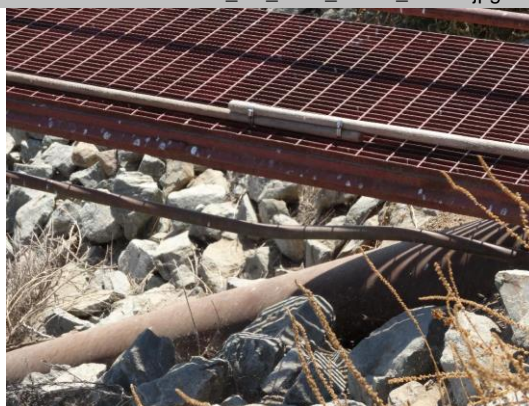
Photo 2 of 3 : UCIP_SP_2019_41600_36003.jpg

Comment Code						
Inspector Comment						
FS_ID:41600						
DS_ID:22691						
EP_NO: N/A						
Repair Type: Non-Urgent						
Crossing Status: Found						
UCIP Comments: - 2" electric conduit on WS- pipe exposed on both						
sides.- power pole on LS. - erosion on WS hinge near walkway.						
FIELD_STRUCT_DESC: 14-inch irrigation discharge pipe of an						
unknown material and a 2-inch electrical conduit of an unknown						
material through the levee, 6 feet below the crown. Pump on a pile						
structure in the stream. Air valve on the landside (LS) shoulder. 30-inch						
concrete standpipe on the LS toe. [Additional Reference(s): DWR						
Levee Log, 2005. USACE San Joaquin O&M Manual 8, 1968, (HLM

WS view: exposed pipe, walkway, and electric conduit under walkway.
Rock revetment on lower levee slope.

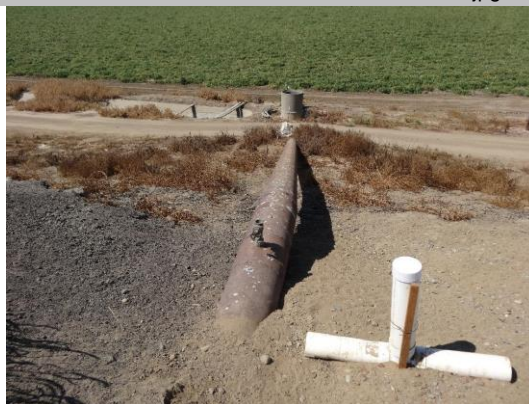
Photo 3 of 3 : UCIP_SP_2019_41600_36002.jpg

LS view: exposed steel pipe on levee slope and concrete standpipe on levee toe.

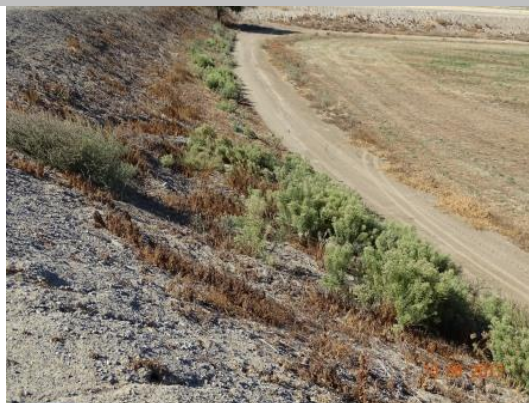
Photo 2 of 2 : SP_2019_RD0001_23_3_20190313_00002.jpg

LM Start	1.08	Rating **	M	Issue No.	3
LM End	1.08	Issue Type +	Ma	Location *	LS
Category	Earthen Levee			GPS Latitude/Longitude	
				Start	End
Item	Slope Stability			37.812023 °	37.812023 °
				-121.383961 °	-121.383961 °
DWR ID	DWR_RD0001_01_s_2016_3				
Comment Code					
S3 : Repair the levee slope damaged by vehicle traffic and prevent access where possible.					
Inspector Comment					
Repair slope damaged caused by vehicle traffic by placing and compacting acceptable levee material.

View of the ruts on the levee slope overgrown with vegetation.

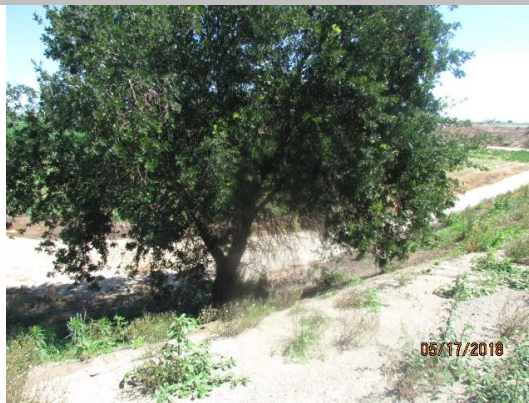
Photo 1 of 1 : SP_2019_RD0001_23_19_20190313_00017.jpg

LM Start	1.13	Rating **	M	Issue No.	19
LM End	1.13	Issue Type +	Ma	Location *	LS
Category	Earthen Levee			GPS Latitude/Longitude	
				Start	End
Item	Trim / Thin Trees			37.811714 °	37.811714 °
				-121.384876 °	-121.384876 °
DWR ID	DWR_RD0001_01_s_2018_19				
Comment Code					
T1 : Trim trees to at least five feet above ground level.					
Inspector Comment

Looking west at untrimmed tree at landward toe. (Spring 2018)
